## HOME INSPECTION REPORT

5606 Irvington Pl, Los Angeles, CA 90042

Inspection Date: 3/10/2021  
Report Number: 2021031003JG  
Real Estate Agent: Ted Clark  
Home Inspector: Jeremy Gauchay

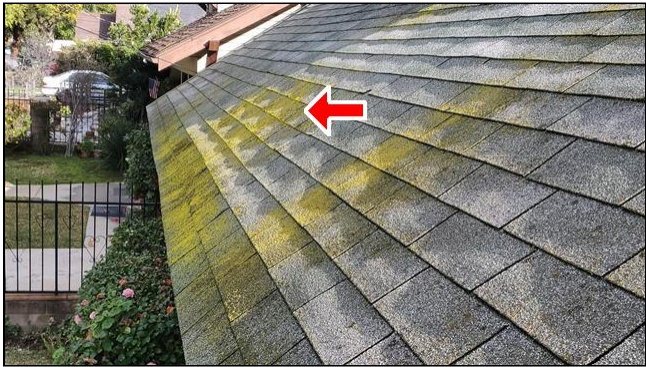
1.0 Item 1(Picture)

(1) Green material observed on coverings. Recommend correcting.

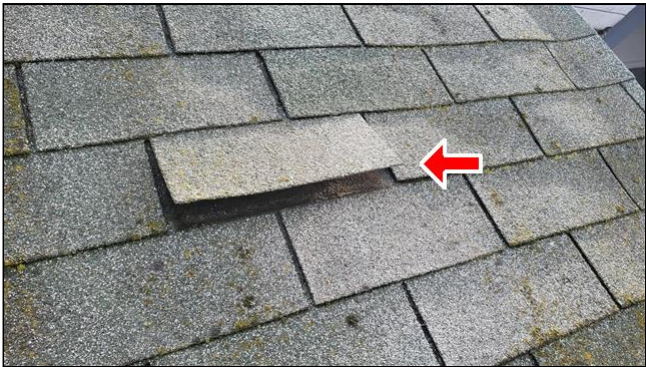
1.0 Item 2(Picture)

(2) Loose roofing material observed. Recommend correcting.

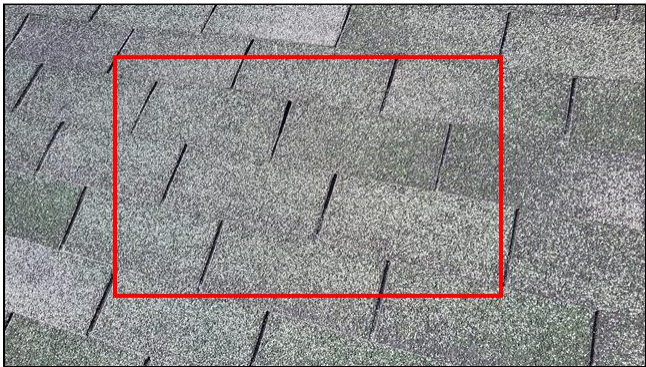
1.0 Item 4(Picture)

(3) Roof coverings are degranulating in areas. Recommend maintenance.

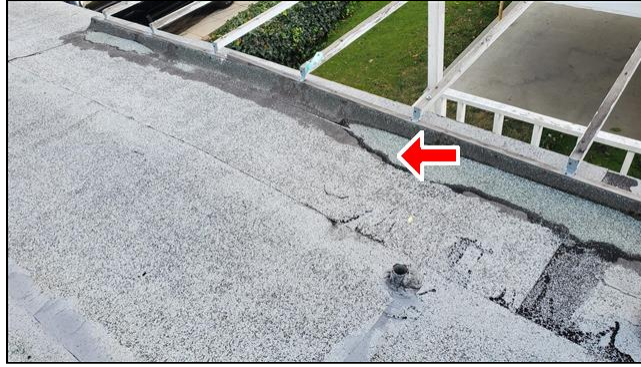
1.0 Item 5(Picture)

🏠 (4) Evidence of inadequate drainage observed. Recommend correcting.

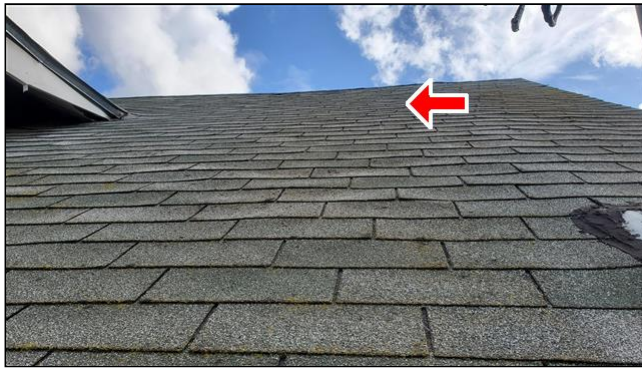
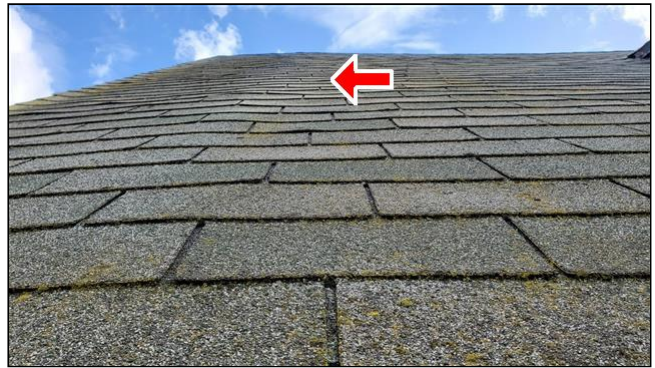
1.0 Item 6(Picture)

(5) Uneven/wavy areas observed. Suggest verifying condition with a qualified roofer.

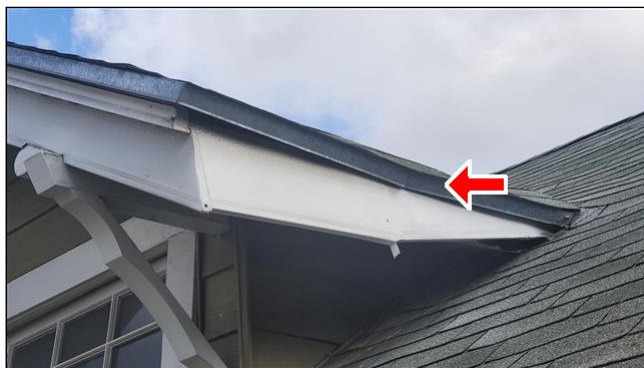
1.2 Item 1(Picture)

Lifting flashing(s) observed at front and rear. Recommend repair.

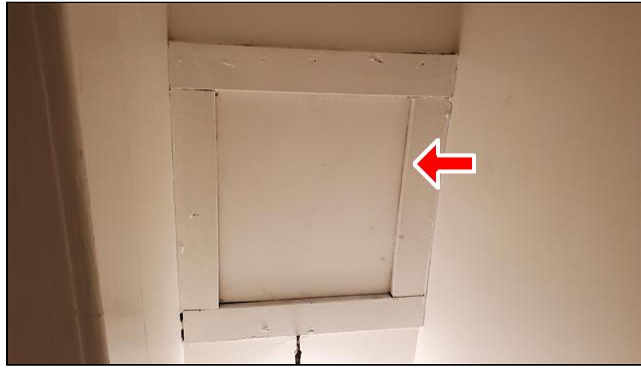
2.0 Item 1(Picture)

Access opening dimensions are not to current standards. Recommend correcting.

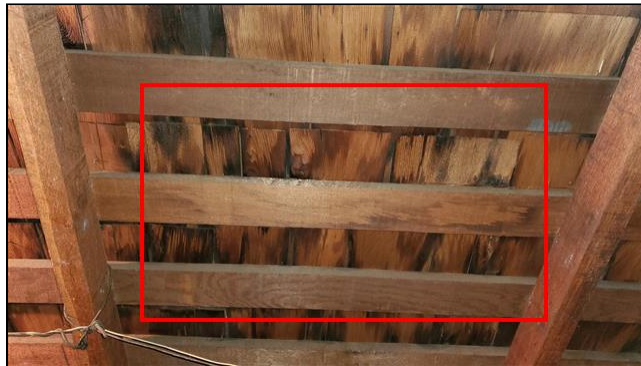
2.1 Item 1(Picture)

(1) Roofing material is installed over wood shakes or wood shingles. Recommend further review by a qualified roofer.

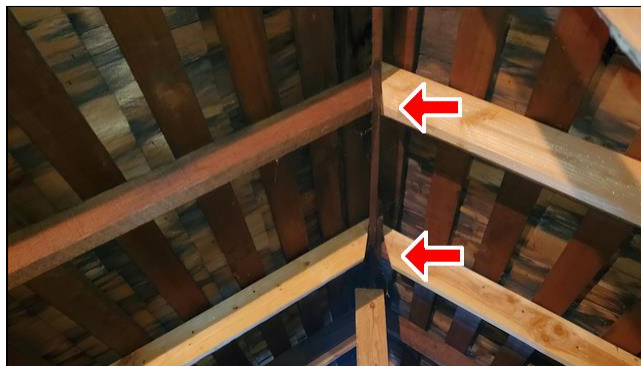
2.1 Item 2(Picture)

(2) Ridge board is undersized or not installed. Recommend further review by a qualified roofer.

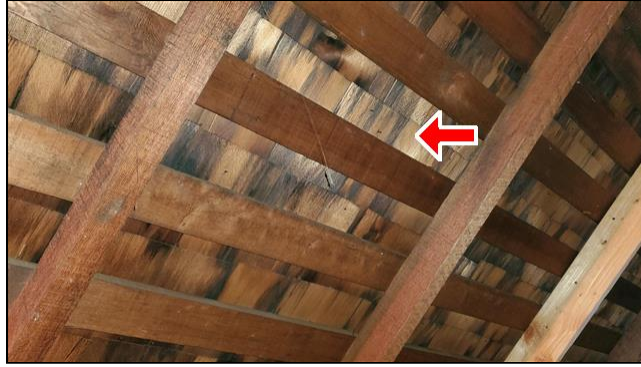
2.2 Item 1(Picture)

Water staining observed at the sheathing. Recommend further review by a qualified roofer.

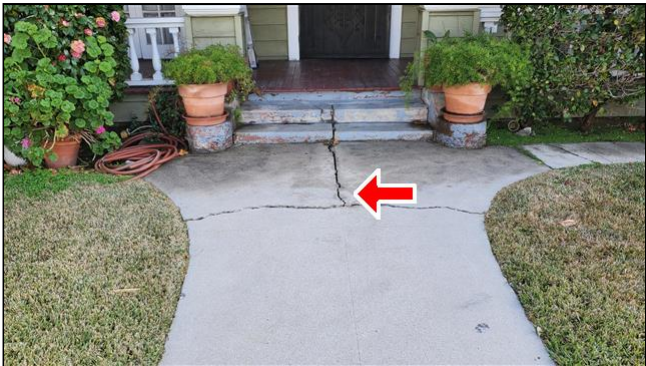
3.0 Item 1(Picture)

Displacement observed at walkway(s). Recommend repair.

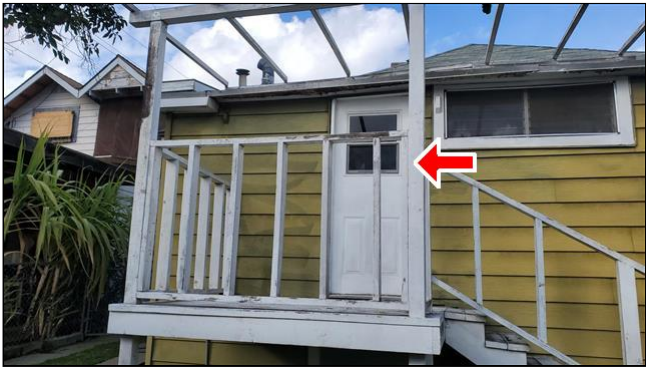
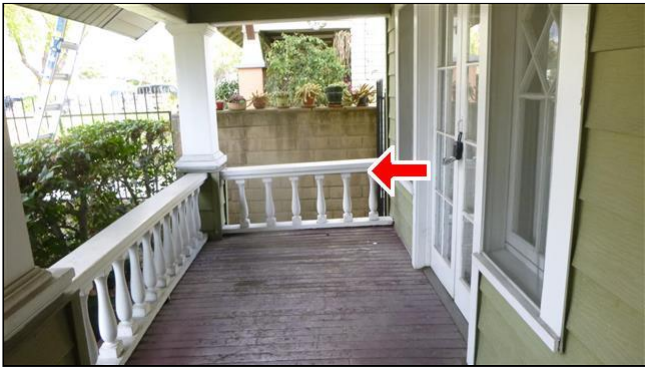
3.1 Item 1(Picture)

🏠 (1) The barrier railing is not installed to meet standards and hand railing is loose at the front and rear (exterior). Recommend correcting.

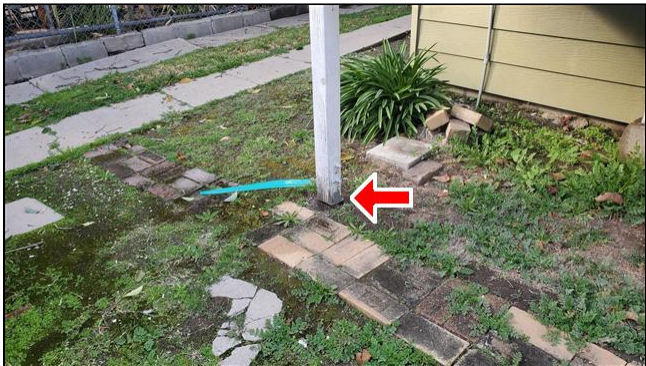
3.1 Item 3(Picture)

🏠 (2) Deterioration observed at one or more support posts located at rear. Recommend repair.

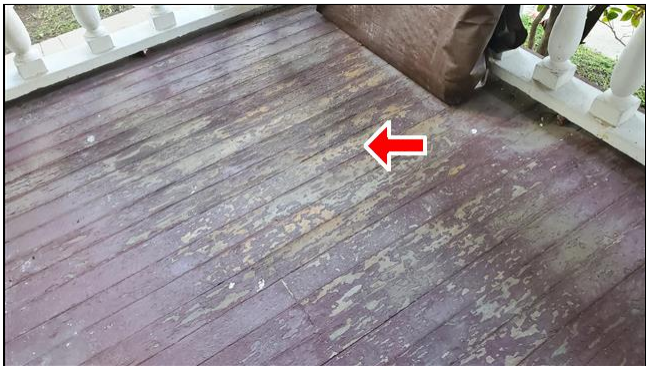
3.1 Item 4(Picture)

🏠 (3) Deteriorated decking/sealant observed at front of the home. Recommend correcting.

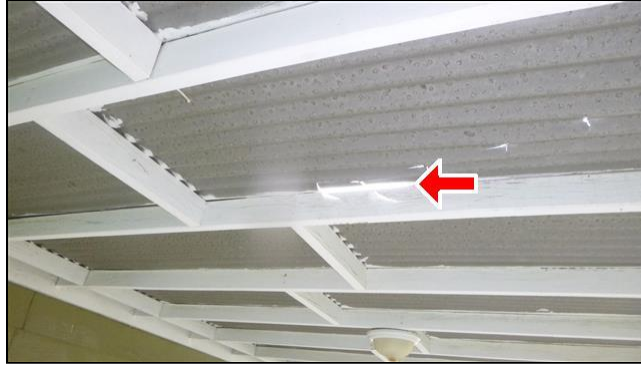
3.1 Item 5(Picture)

- 🏠 (4) Gaps observed at patio cover at rear exterior. Recommend correcting.

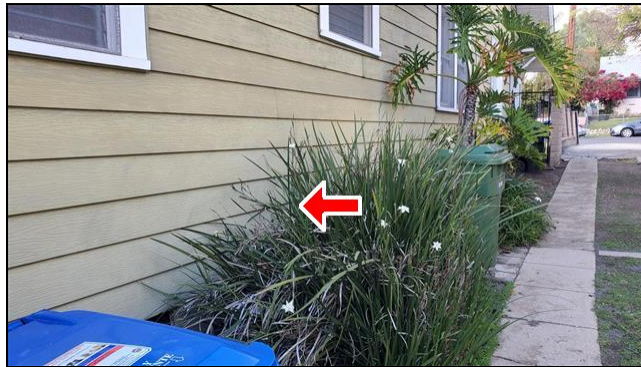
3.2 Item 1(Picture)

- 🏠 (1) Vegetation is in direct contact with the wall cladding. Recommend trimming or removal.

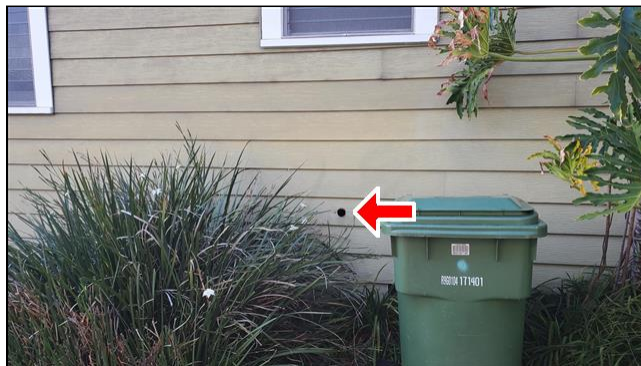
3.2 Item 2(Picture)

- 🏠 (2) Holes observed at left side of the home. Recommend repair.

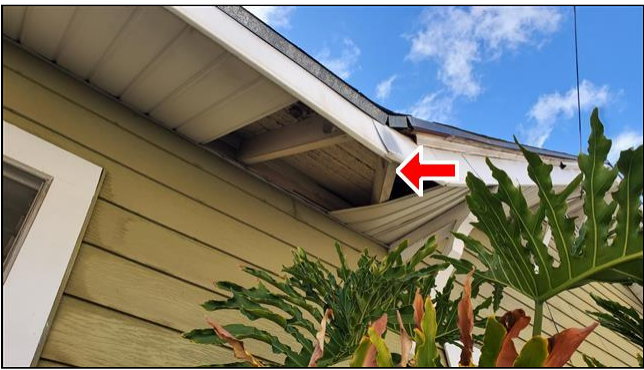
3.3 Item 1(Picture)

(1) Split/broken panels observed at left side eaves. Recommend repair.

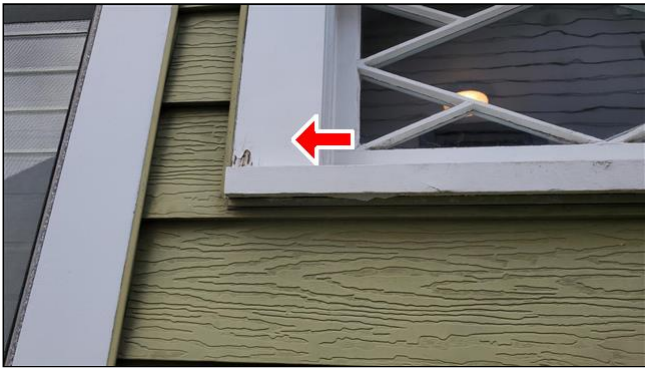
3.3 Item 2(Picture)

(2) Deterioration observed in areas. Recommend further evaluation by a qualified termite specialist.

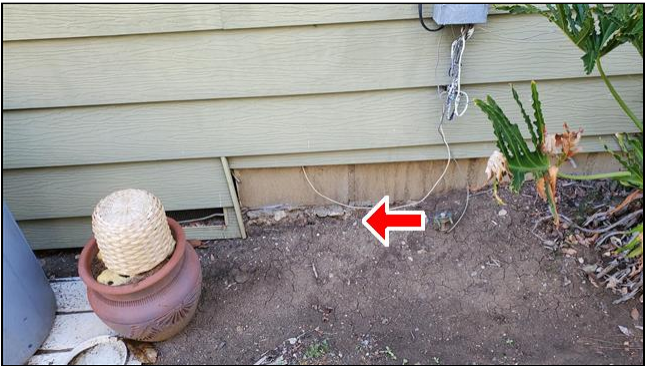
3.5 Item 1(Picture)

(1) Exposed footing observed. Recommend correcting.

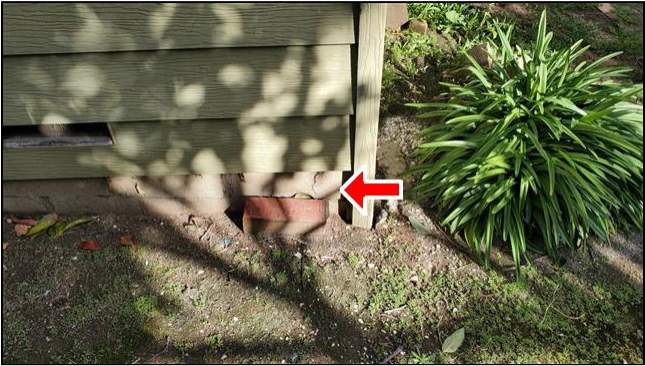
3.5 Item 2(Picture)

(2) Cracking observed at right side. Recommend repair.

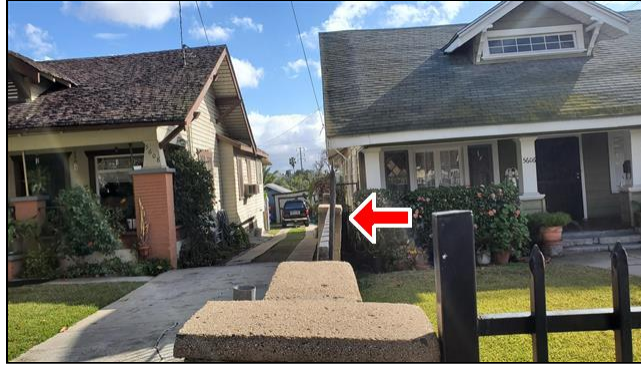
3.8 Item 1(Picture)

🏠 (1) Leaning observed at the left side wrought iron fencing. Recommend correcting.

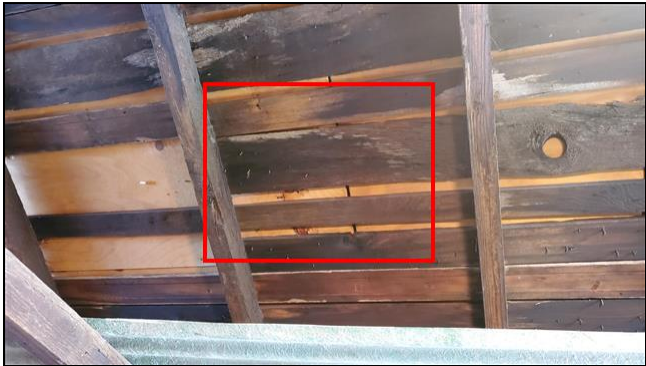
4.0 Item 1(Picture)

Water staining observed at the sheathing. Recommend further review by a qualified roofer.

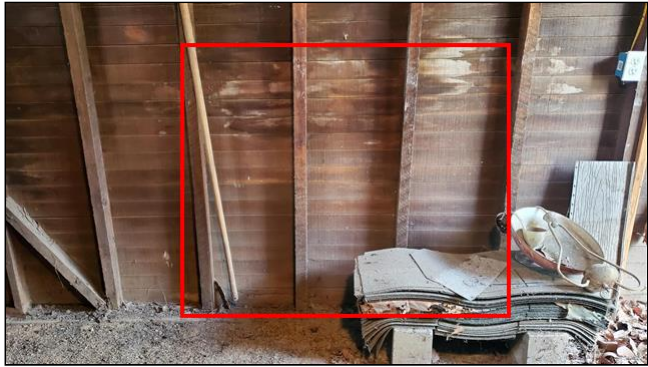
4.1 Item 1(Picture)

Leaning structure or wall observed at garage. Recommend further review by a qualified contractor.

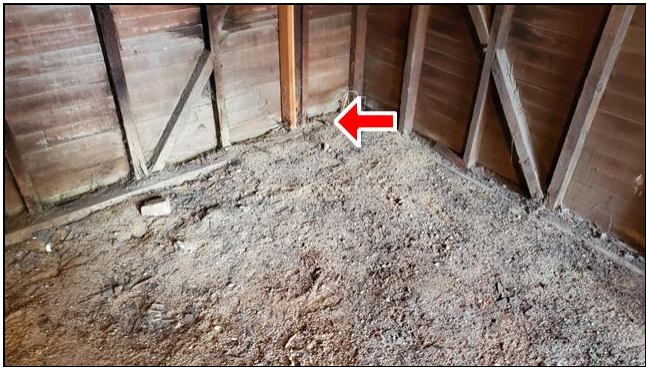
4.2 Item 1(Picture)

Garage walls/sill plate are not anchored to the foundation and in contact with soil. Recommend correcting.

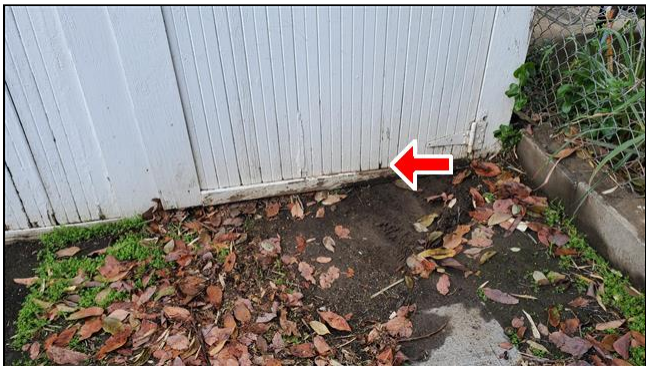
4.3 Item 1(Picture)

Deterioration observed at garage door. Recommend repair/replacement.

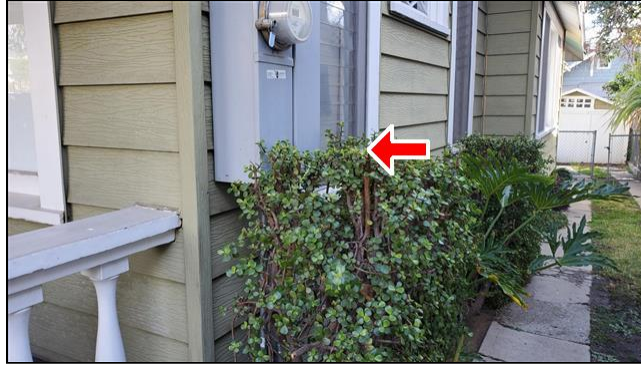
5.1 Item 1(Picture)

🏠 Vegetation has overgrown main panel. Recommend correcting.

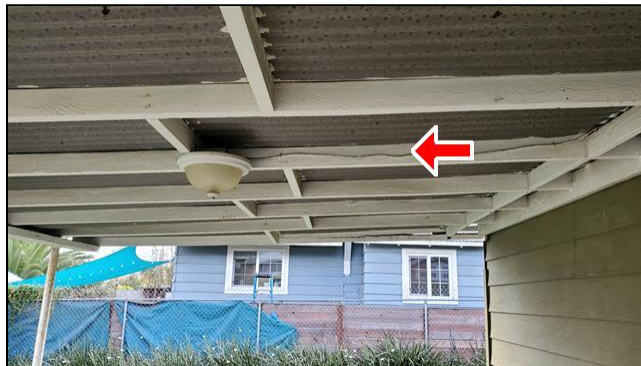
5.3 Item 1(Picture)

🏠 (1) Unprotected wiring observed at garage. Recommend correcting.

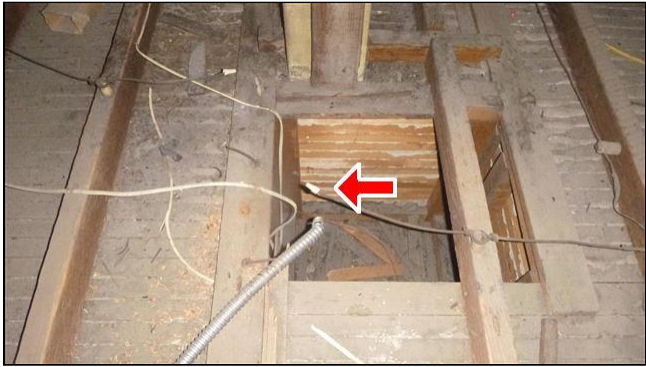
5.3 Item 4(Picture)

(3) Exposed wiring observed at attic. Recommend correcting.

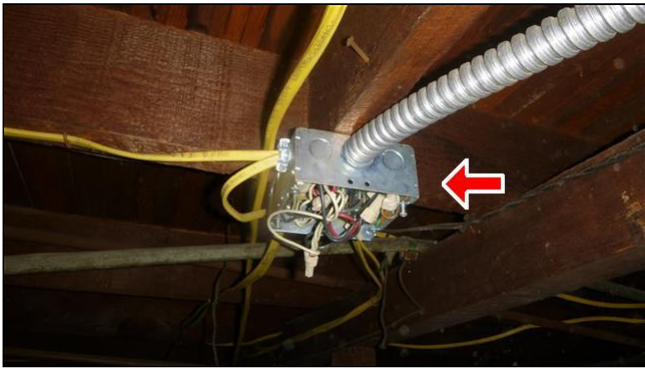
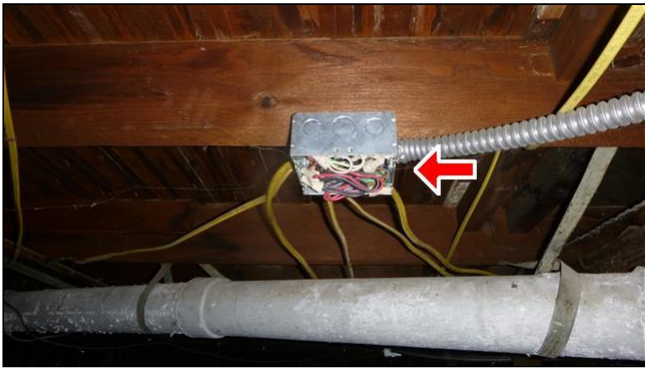
5.3 Item 5(Picture)

(4) Open junction boxes observed at crawlspace. Recommend correcting.

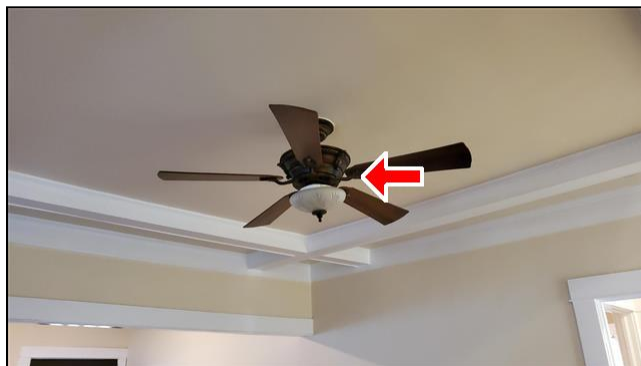
5.5 Item 1(Picture)

🏠 Ceiling fan did not respond to test at living room. Recommend correcting.

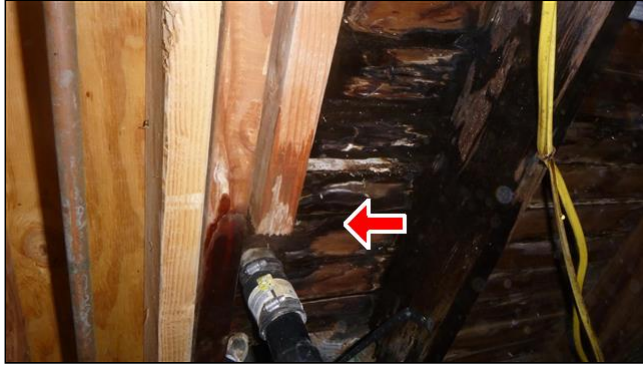
6.2 Item 1(Picture)

🏠 (1) Leaking observed at drain lines. Recommend further review by a qualified plumber.

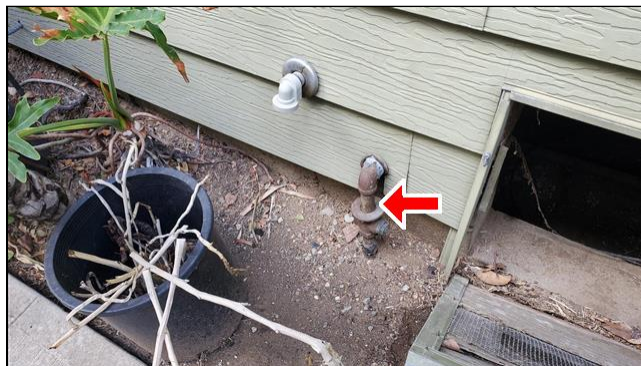
6.3 Item 1(Picture)

🏠 (2) Rust/corrosion observed at the gas supply piping. Recommend further review by a qualified plumber.

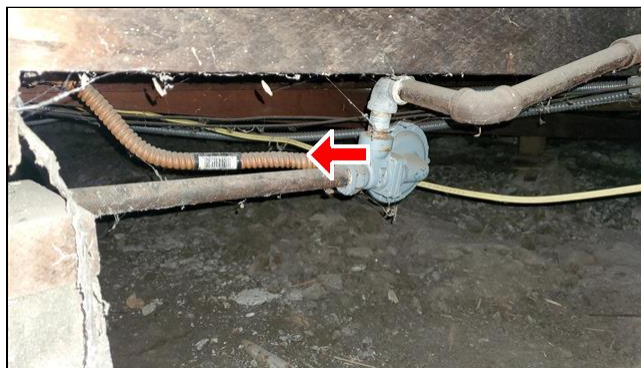
6.3 Item 2(Picture)

📍 (3) Incorrect material used at gas supply line. Recommend correcting.

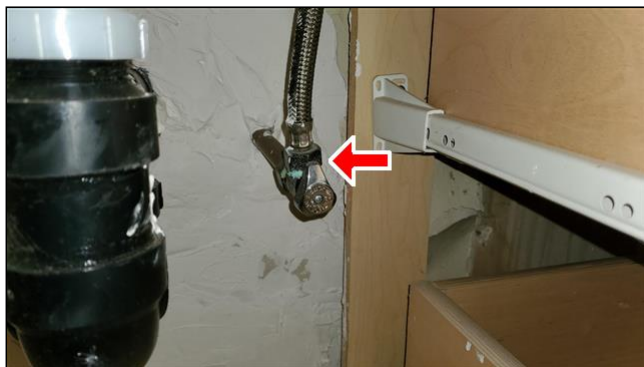
6.5 Item 1(Picture)

📍 Rust and corrosion observed at hall bathroom sink drain and shut off valves. Recommend correcting.

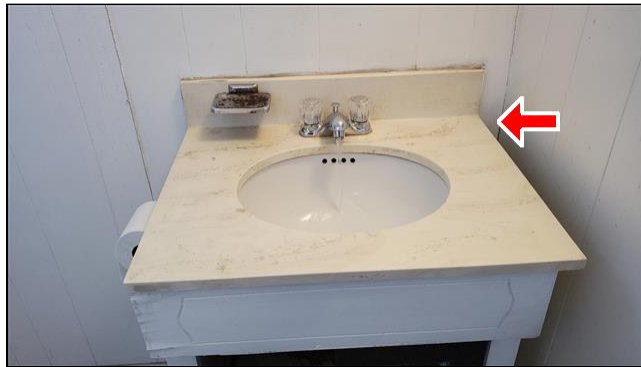
6.6 Item 2(Picture)

🏠 (3) Sink is loose/not secure at rear/right bathroom. Recommend repair.

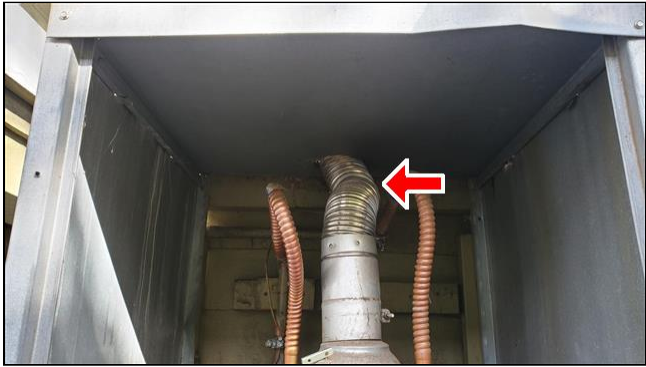
7.0 Item 1(Picture)

(1) Incorrect material used for exhaust vent pipe. Recommend correcting.

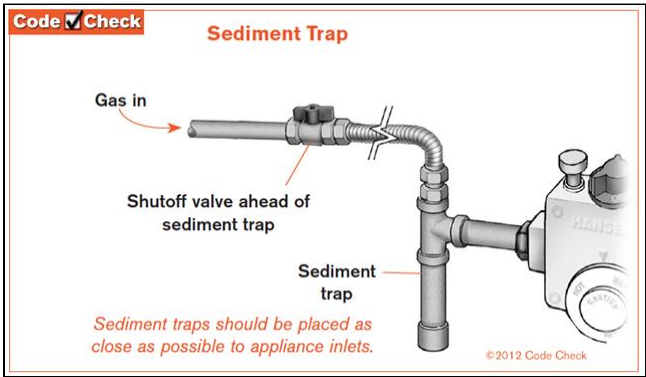
7.1 Item 1(Picture) Sed Traps

Sediment trap is not plumbed on the gas line. Recommend correcting.

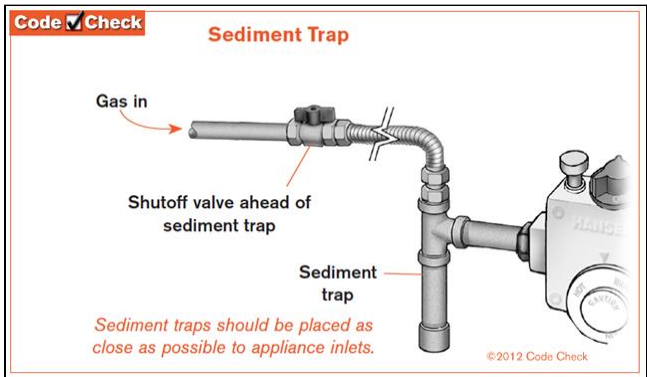
8.1 Item 1(Picture) Sediment Trap

📌 (1) Sediment trap is not plumbed on the gas line. Recommend correcting.

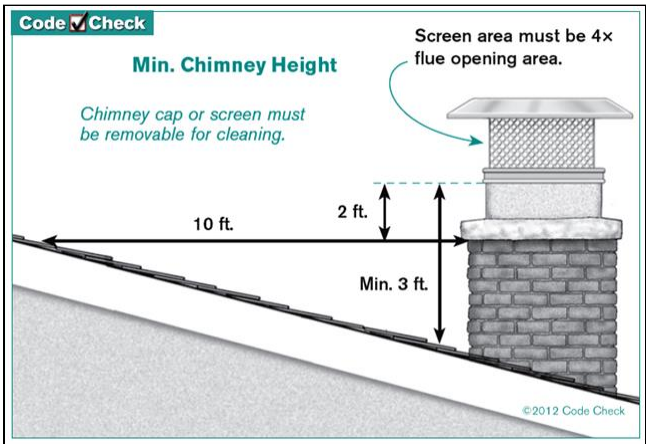
9.0 Item 1(Picture) Chimney Clearance

(1) Chimney does not terminate 2 feet above the roofline within 10 feet of the structure. Suggest correcting.

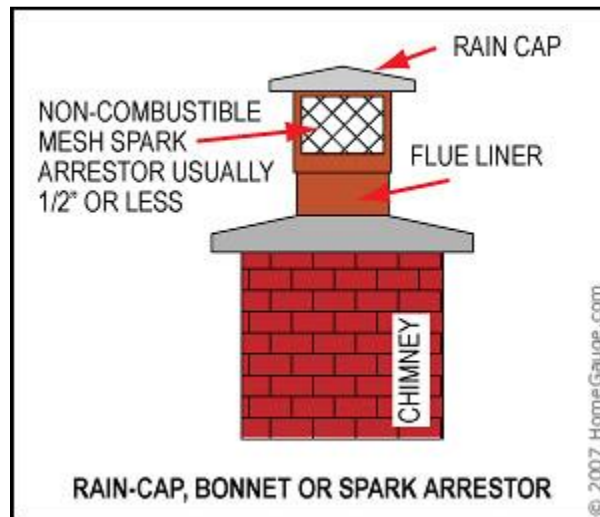
9.1 Item 1(Picture) Spark Arrestor

- 🏠 (1) Spark arrestor with rain cover is not installed. Recommend installing.

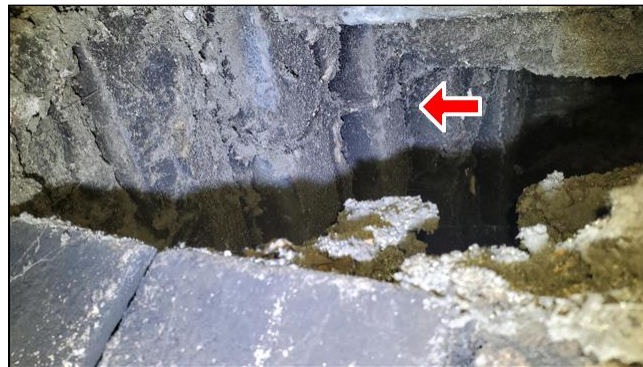
9.3 Item 1(Picture)

- 🏠 (2) Smoke chamber is not parged smooth. Recommend further review by a qualified fireplace specialist.

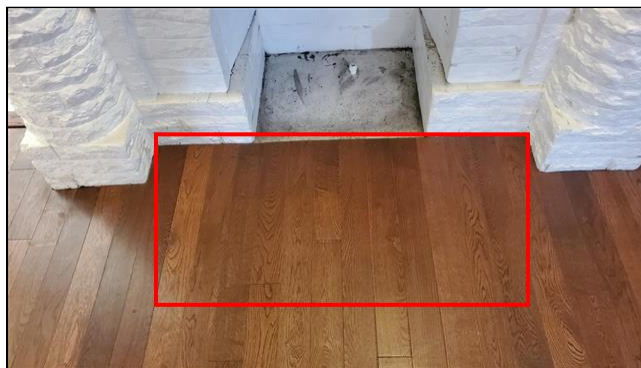
9.3 Item 2(Picture)

🏠 (3) Hearth extension is covered up at living room. Recommend correcting.

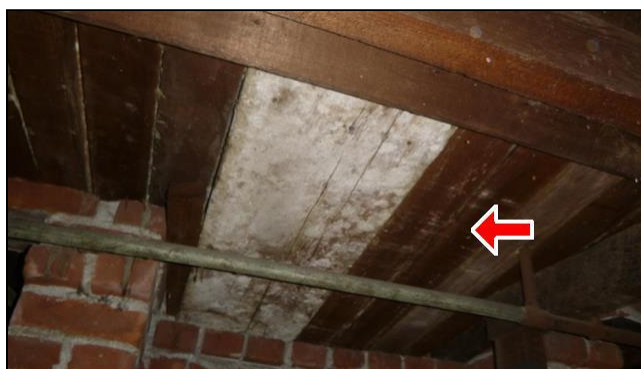
9.3 Item 3(Picture)

🏠 (4) Wood form remains under the hearth at living room. Recommend removal.

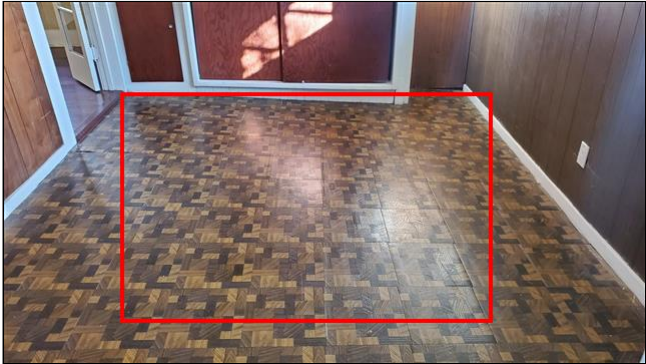
11.0 Item 1(Picture)

🏠 (1) Sloping floor observed at rear/left bedroom and rear/right bathroom. Recommend further review by a structural engineer.

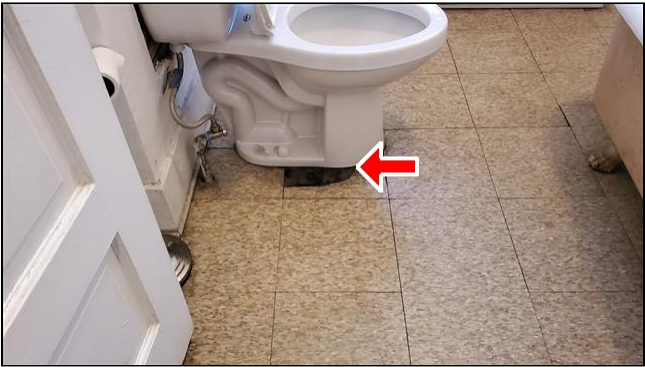
11.0 Item 3(Picture)

🏠 (2) Laminate is not sealed at the hall bathroom toilet. Recommend repair.

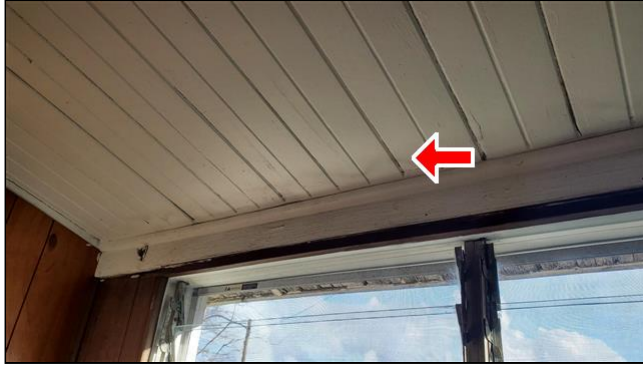
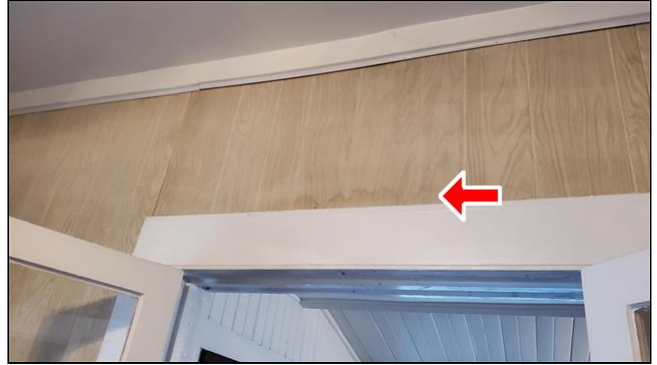
11.1 Item 1(Picture)

🏠 (2) Moisture staining observed at rear/left bedroom ceiling and walls. Hidden damage may not be observable. Recommend further review by a qualified professional.

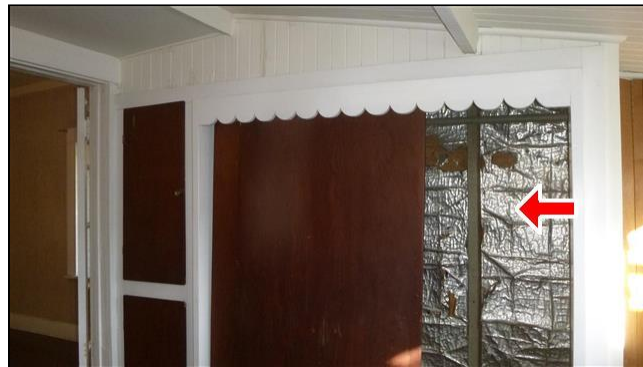
11.1 Item 3(Picture)

🏠 (3) Unfinished walls observed at rear/right bedroom closet. Recommend correcting.

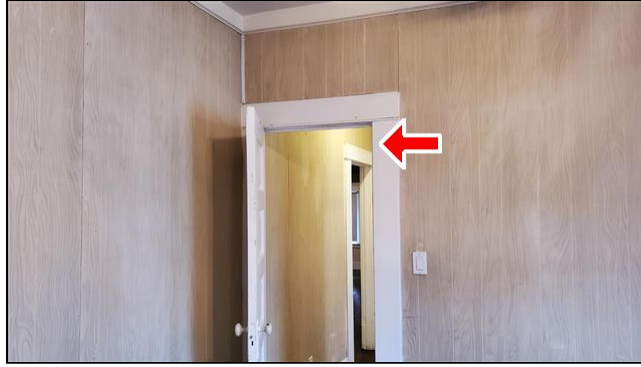
11.2 Item 1(Picture)

- 🏠 (1) The door at center/left bedroom sticks/rubs frame when opening and closing. Recommend repair.

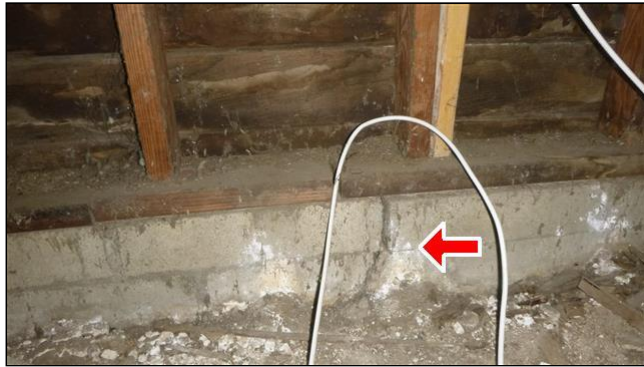
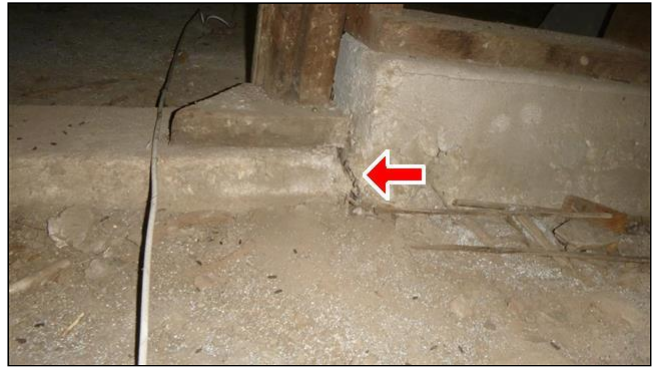
12.1 Item 1(Picture)

- 🏠 (1) Cracking observed at the stem walls. Recommend further review by a qualified foundation specialist.

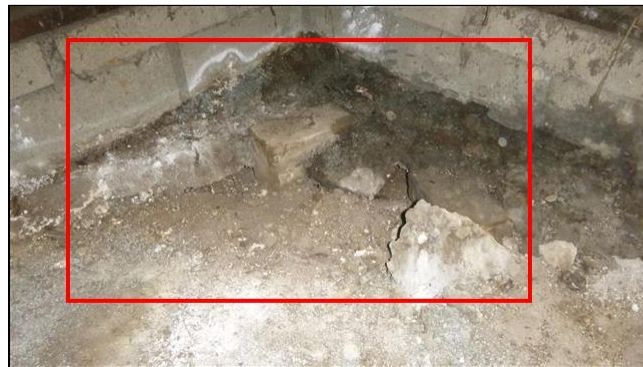
12.1 Item 3(Picture)

- 🏠 (2) Exposed footing observed. Recommend correcting.

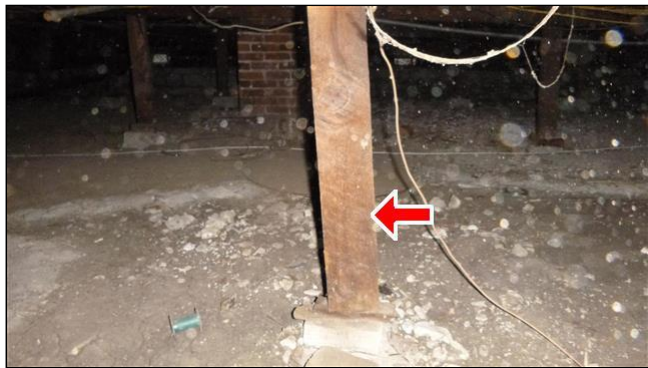
12.3 Item 1(Picture)

(1) Posts are off center and leaning. Recommend further review by a qualified foundation specialist.

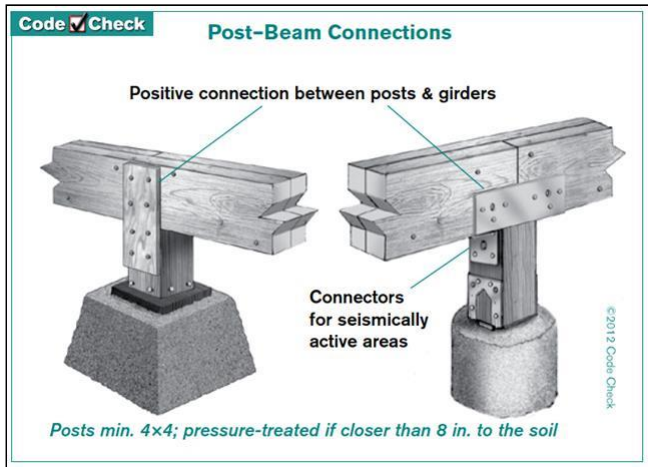
12.3 Item 5(Picture)

(2) Posts are inadequately sized (2x4). Recommend correcting.

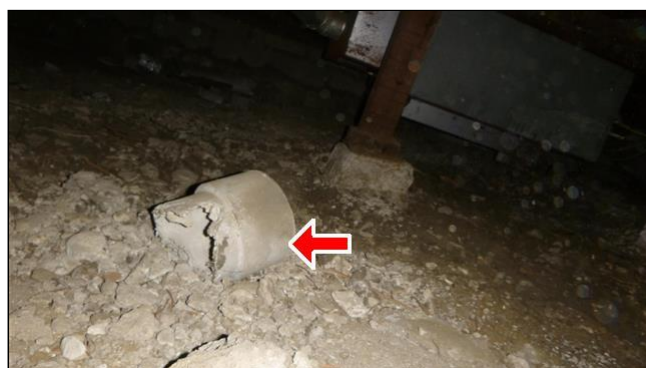
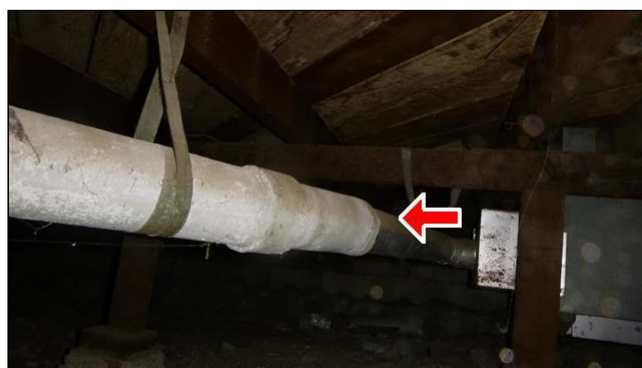
12.7 Item 1(Picture)

🏠 (2) Damaged/abandoned transite vent pipe (asbestos) debris observed. Recommend removal.
