## HOME INSPECTION REPORT

5606 Irvington Pl, Los Angeles, CA 90042

Inspection Date: 3/10/2021  
Report Number: 2021031003JG  
Real Estate Agent: Ted Clark  
Home Inspector: Jeremy Gauchay

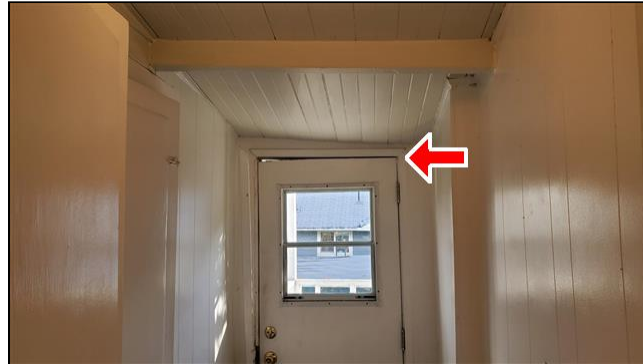
3.6 Item 1(Picture)

🏠 (1) Door is not square to frame at rear. Recommend repair.

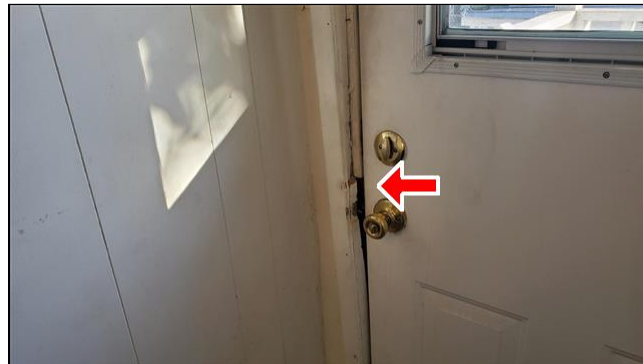
3.6 Item 2(Picture)

🏠 (2) Physically damaged door/door frame at rear. Recommend repair.

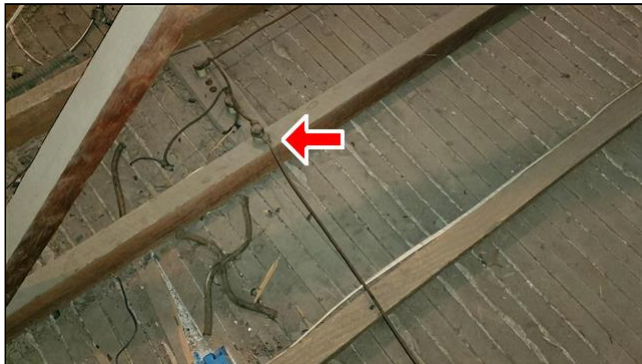
5.3 Item 2(Picture)

🏠 (2) Knob and tube wiring observed. Due to the age of this type of wiring, it is recommended that the client verify the overall condition of the wiring with a qualified electrician.

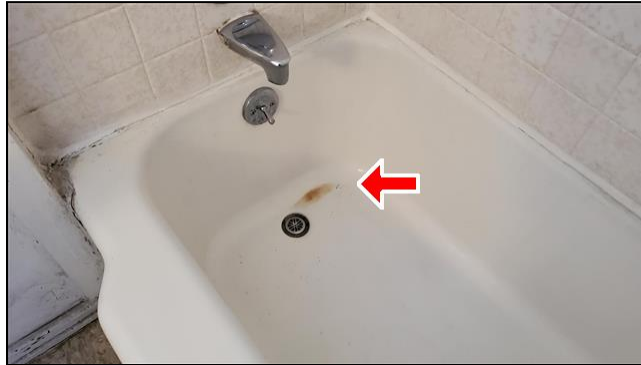
6.6 Item 1(Picture)

🏠 (2) Deteriorated tub/shower surface at rear/right bathroom. Recommend repair.

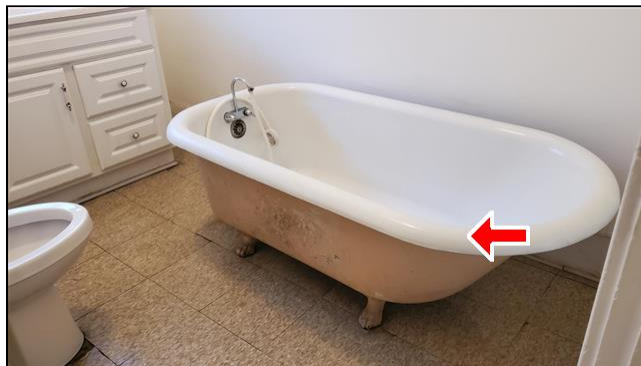
6.6 Item 3(Picture)

🏠 (5) Soaker tub is not secured to the ground at hall bathroom. Recommend correcting.

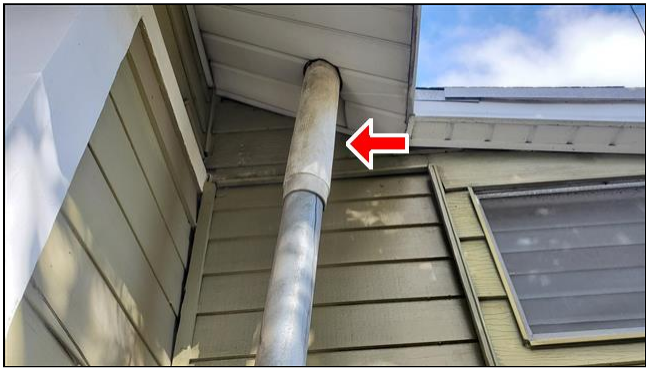
7.0 Item 2(Picture)

(2) Transite (asbestos) pipe used for exhaust vent pipe. Suggest removal.

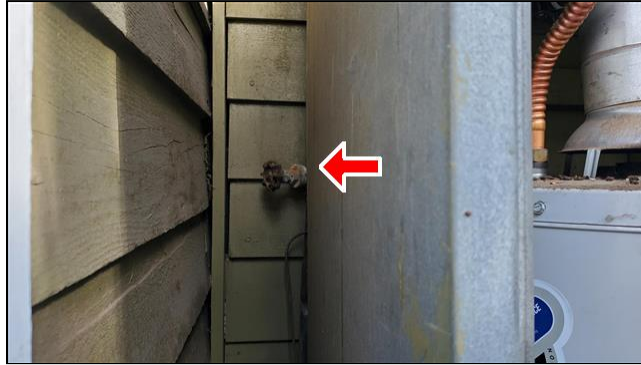
7.2 Item 1(Picture)

🏠 Corrosion observed at supply piping and a gate type valve is installed. Recommend correcting and upgrading to a ball valve type.

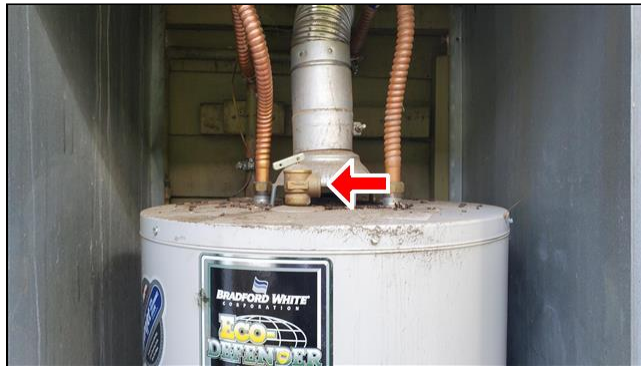
7.3 Item 1(Picture)

🏠 Temperature pressure relief valve is installed without a discharge line. Recommend correcting.

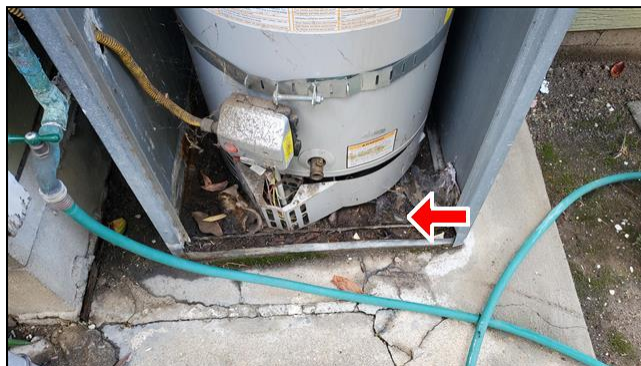
7.5 Item 1(Picture)

🏠 Water staining/damage observed at water heater closet. Recommend further review by a qualified professional.

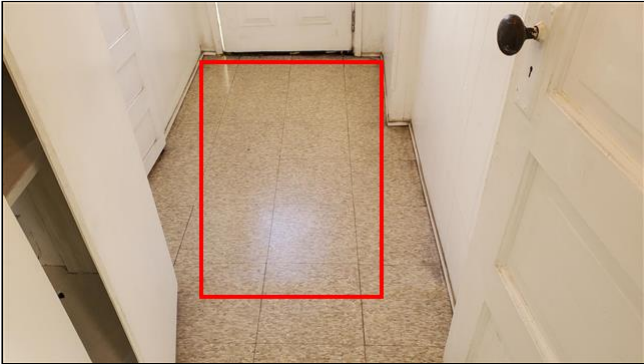
11.0 Item 2(Picture)

🏠 (1) Sloping floor observed at rear/left bedroom and rear/right bathroom. Recommend further review by a structural engineer.

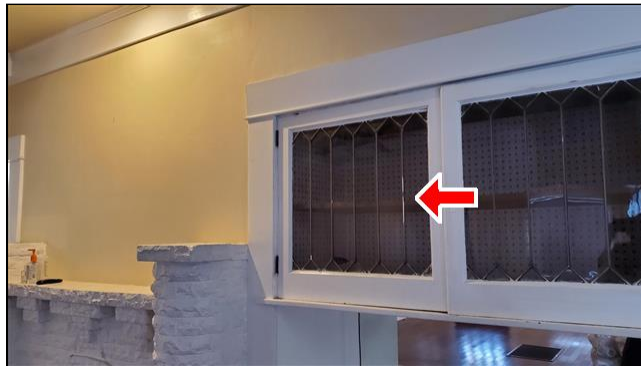
11.4 Item 1(Picture)

- 🏠 (1) Cabinet doors do not open/close correctly and broken glass observed at living room. Recommend correcting.

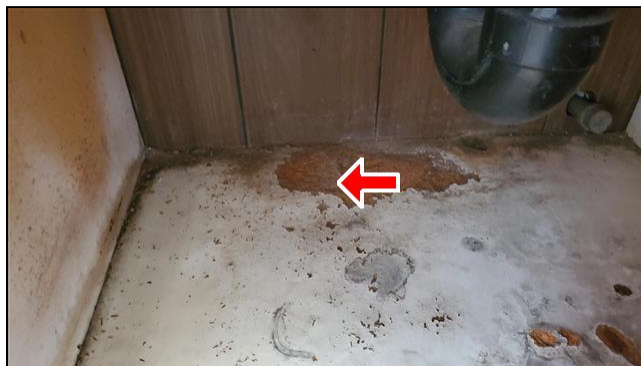
11.4 Item 2(Picture)

🏠 (2) Moisture damage observed at rear/right bathroom cabinetry. Hidden damage may not be observable. Recommend further review by a qualified professional.

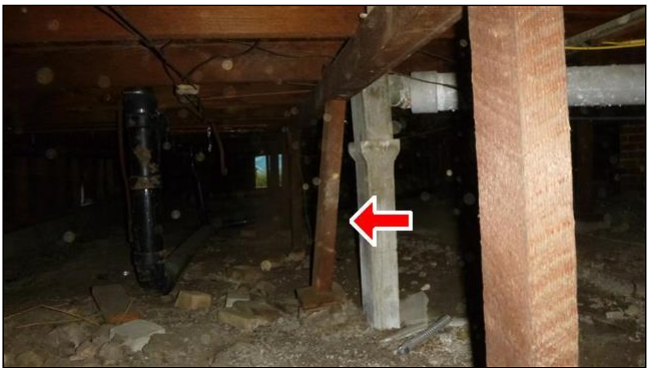
12.3 Item 2(Picture)

(1) Posts are off center and leaning. Recommend further review by a qualified foundation specialist.

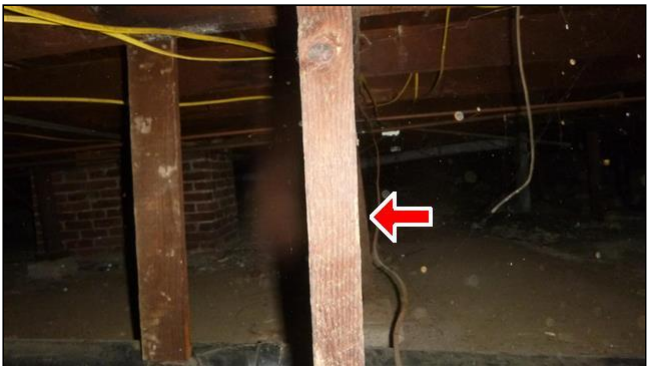
12.3 Item 6(Picture)

(2) Posts are inadequately sized (2x4). Recommend correcting.

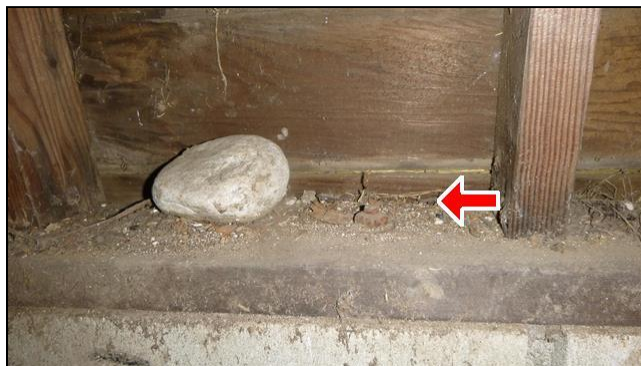
12.4 Item 1(Picture)

Sill plate is bolted to the foundation. Determining the number of bolts required is beyond the scope of this inspection.
